**EFFECT OF TEMPERATURE AND STEAM ENVIRONMENT ON FATIGUE
BEHAVIOR OF AN OXIDE-OXIDE CONTINUOUS FIBER CERAMIC
COMPOSITE**

Chalene A. Eber, First Lieutenant, USAF

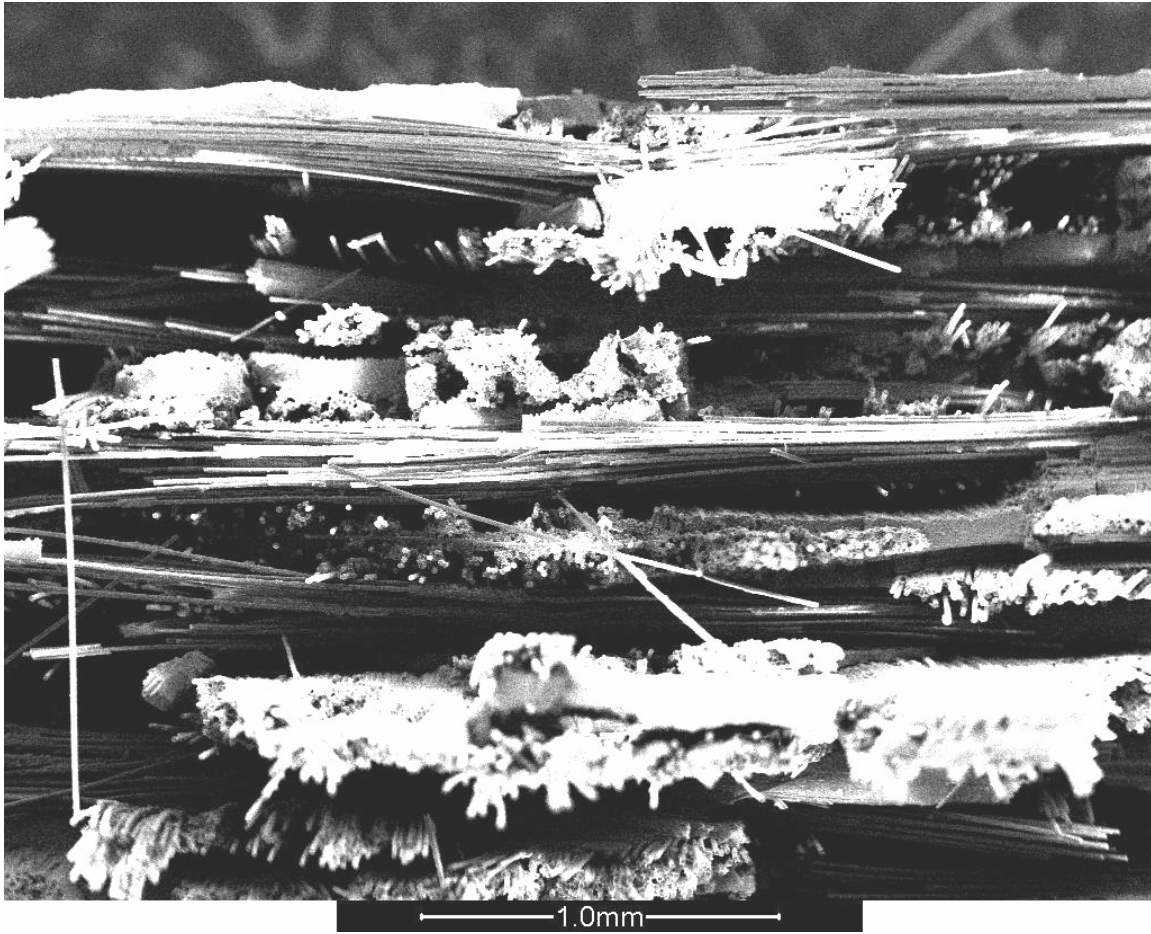
Figure 44. SEM micrograph of Specimen 12, failed in monotonic tension testing following 100,780 cycles of fatigue loading (defined as a run-out) with maximum stress of 100 MPa in steam at 1200°C.

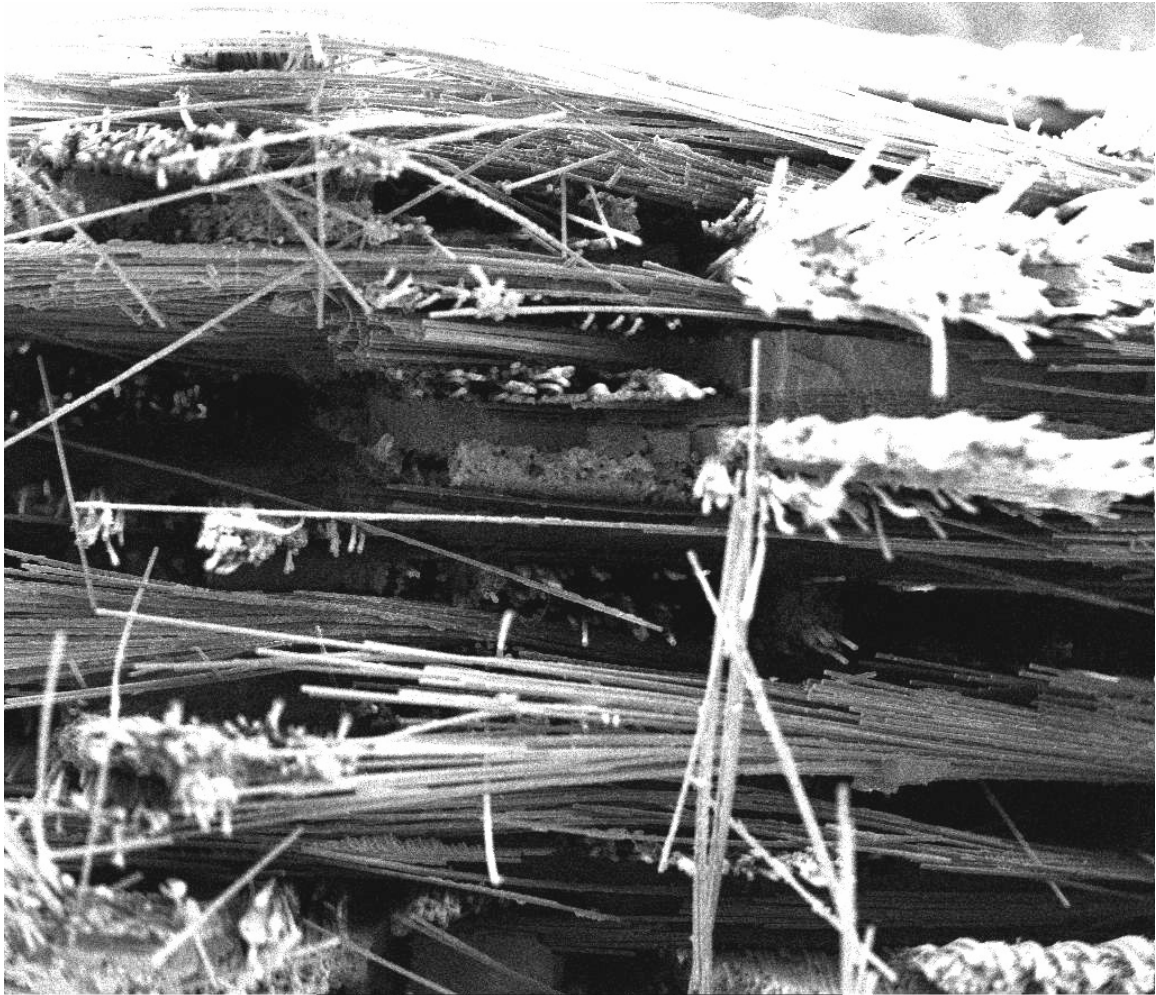
Figure 49. SEM micrograph of Specimen 14, failed in fatigue loading at 150 MPa in steam at 1200°C.

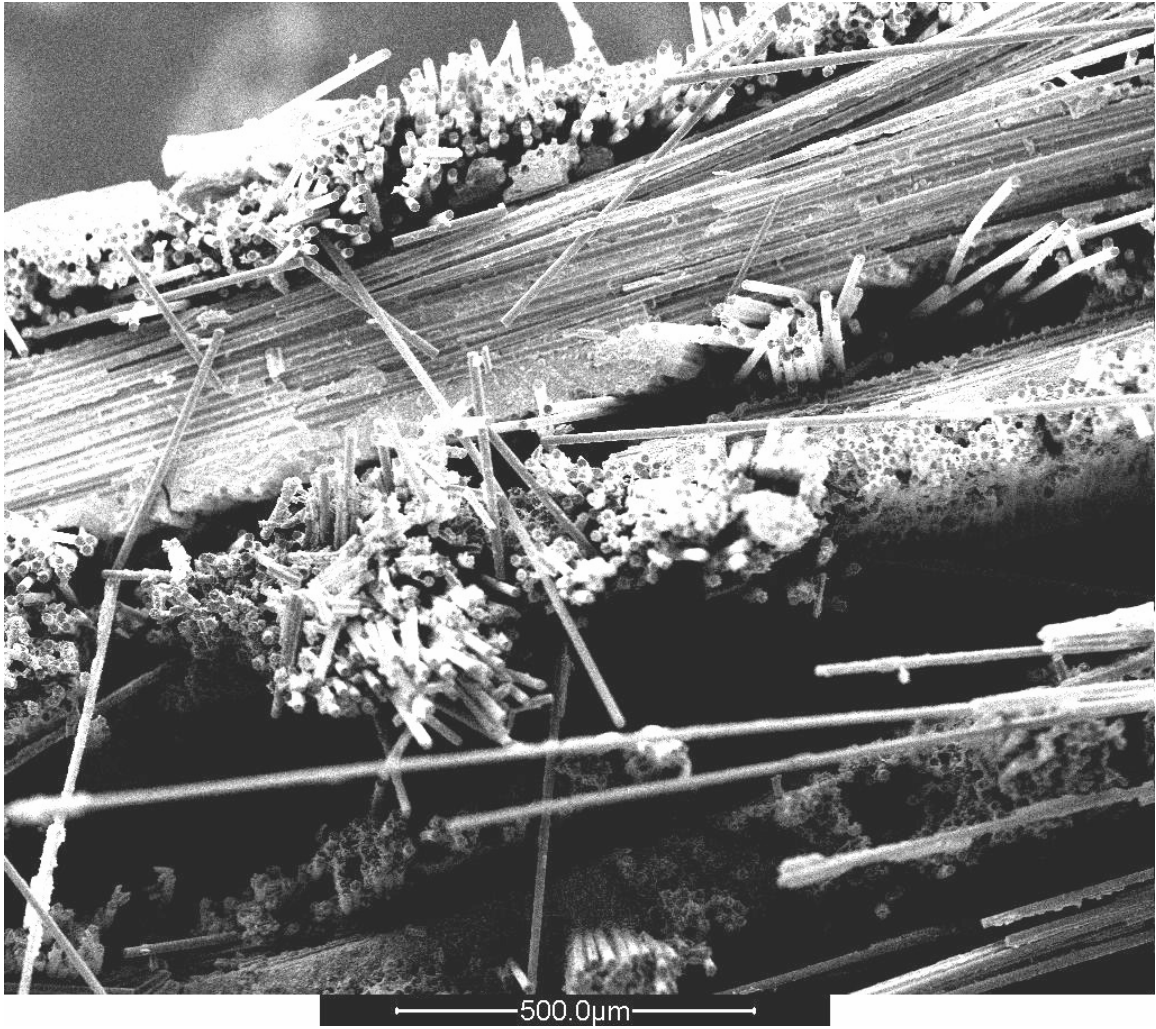
Figure 51. SEM micrograph of Specimen 15, failed during fatigue loading at 170 MPa in steam at 1200°C.

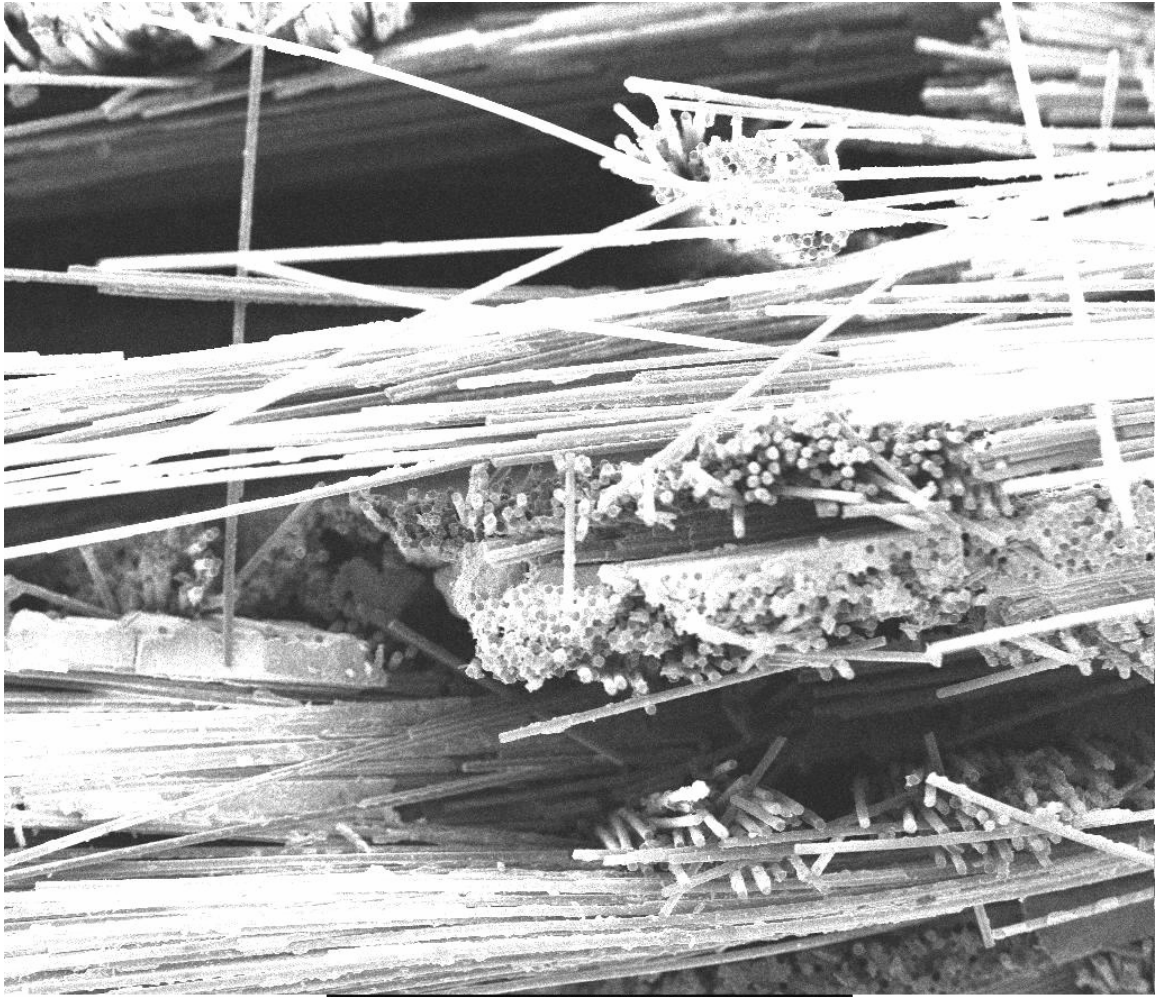
Figure 58. SEM micrograph of Specimen 11 failed under fatigue loading conditions with maximum stress of 100 MPa at 1330°C in air.

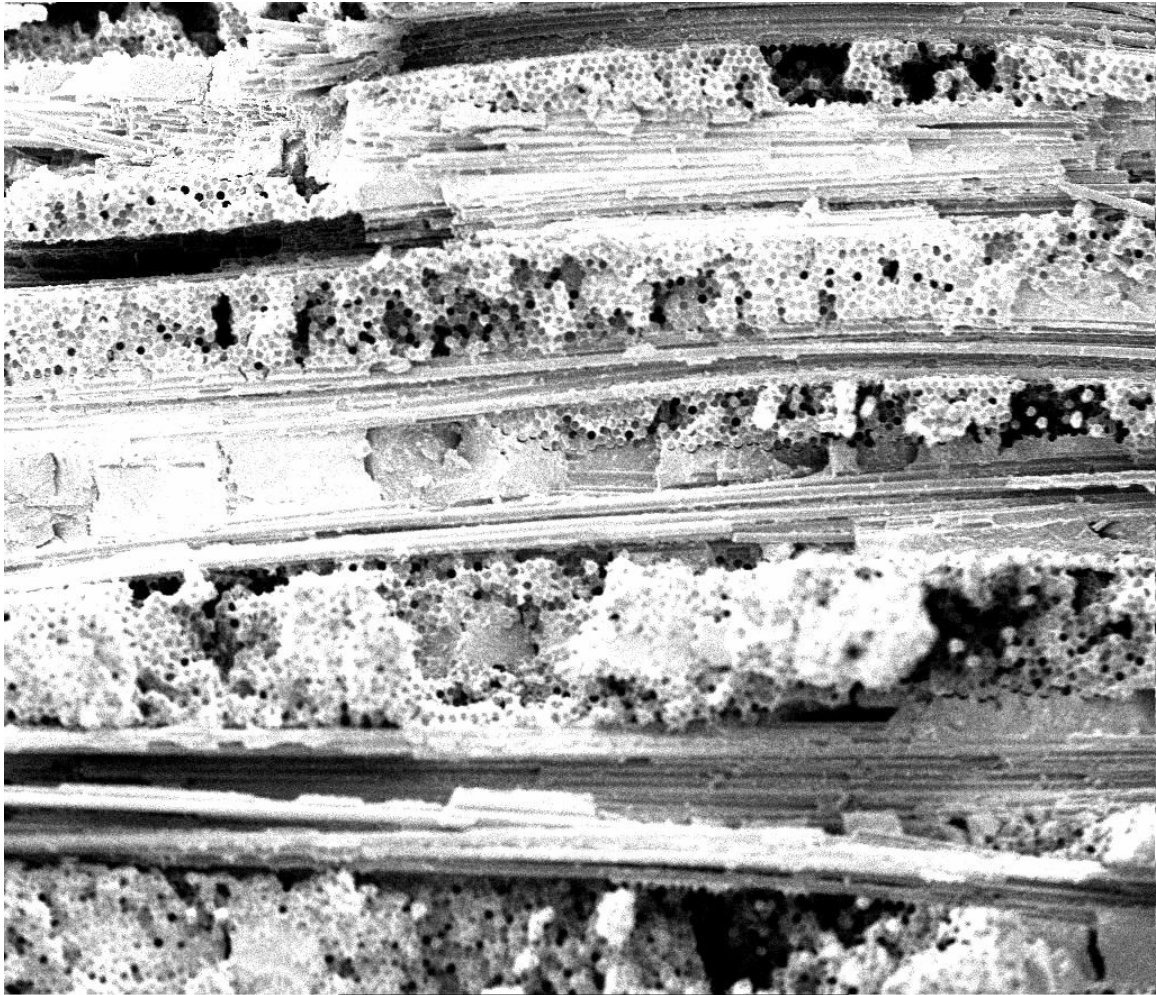
Figure 60. SEM micrograph of Specimen 16 failed under fatigue loading conditions with maximum stress of 50 MPa at 1330°C in steam.
